FIRE-FLOOD SEQUENCES

*...on the San Dimas
Experimental Forest*

TECHNICAL PAPER No. 62
MARCH 1954

FOREST SERVICE, - U. S. DEPARTMENT OF AGRICULTURE
CALIFORNIA FOREST AND RANGE EXPERIMENT STATION,
GEORGE M. JEMISON, DIRECTOR

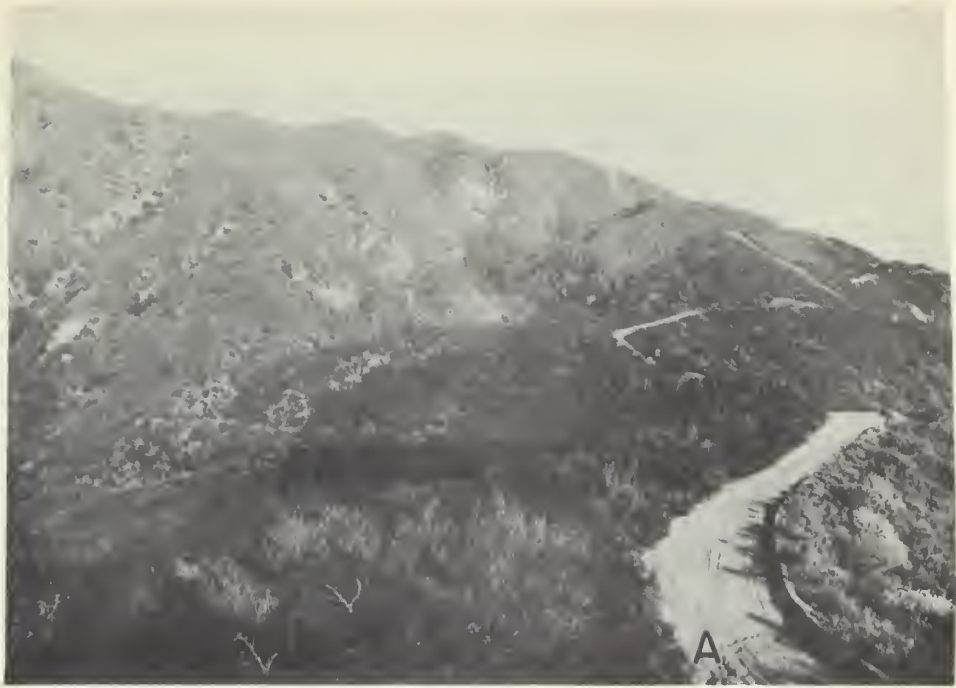
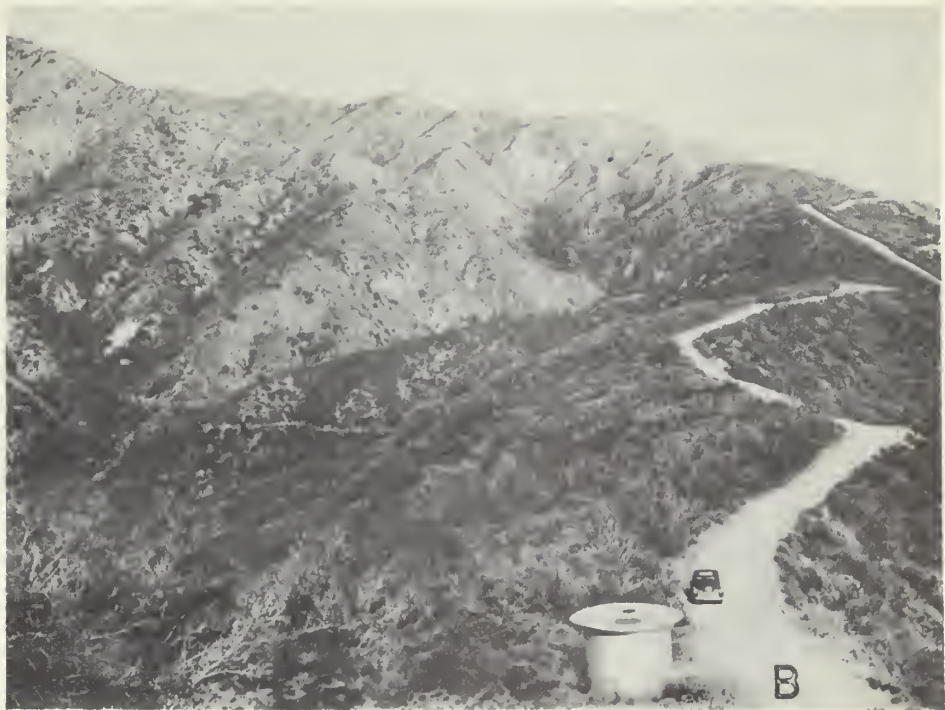
Figure 5.--The upper part of watershed I, Wolfskill Canyon of the San Dimas Experimental Forest, from the south ridge. Elevations range from 3,100 feet in foreground, to 4,800 feet on background ridge. A: The watershed in 1945, unburned for more than 50 years. B: The watershed in 1954, after the far slopes had been burned by the Barrett fire break-out of December 1953.

The headwaters area of watershed I was very severely burned over (table 2, figs. 5 and 6). Crowns of all the oaks were consumed, and in a small plantation of Coulter pine there probably are no trees now alive. The fire also crowned in the oak-woodland type in fringes along the southern boundary and in the upper southeastern part of the watershed. In the latter area big-cone spruce received its greatest damage and shows the most singeing. Where the fire did not crown in oak-woodland and bigcone spruce the litter under the trees was burned severely and a large percentage of the crowns was singed. The leaves will drop from these damaged crowns; some of the oak trees will undoubtedly sprout from their branches. Practically all the chamise chaparral and most of the heavy brush within the firelines was consumed. Only a small percentage of chamise chaparral near the north end of the fireline in watershed I was partially burned. The open semibarren and woodland-sage areas were often spottily burned, with large shrubs and trees generally untouched.

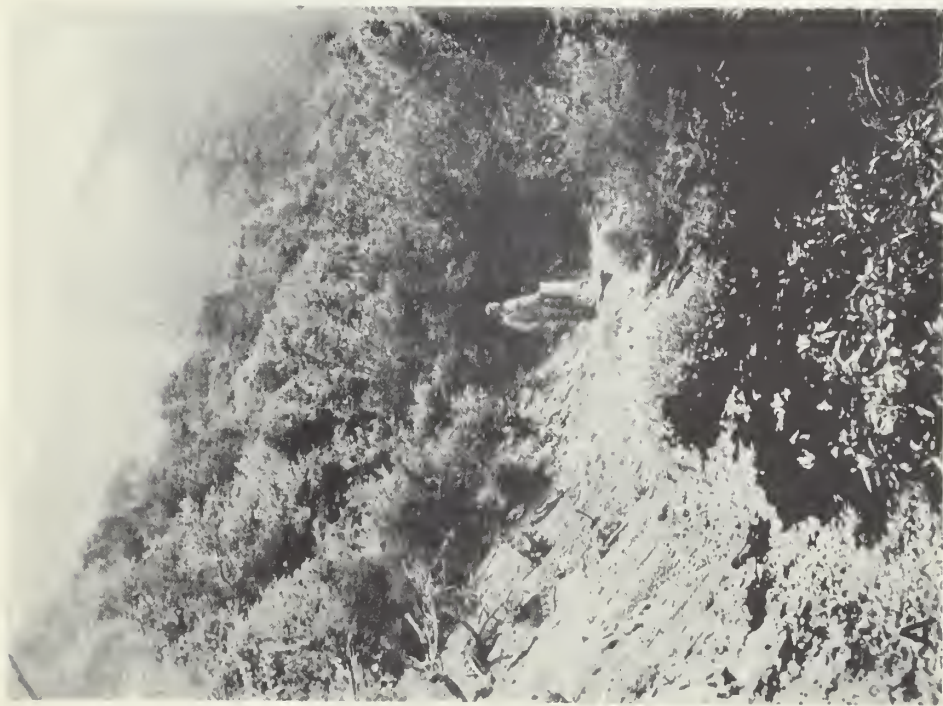
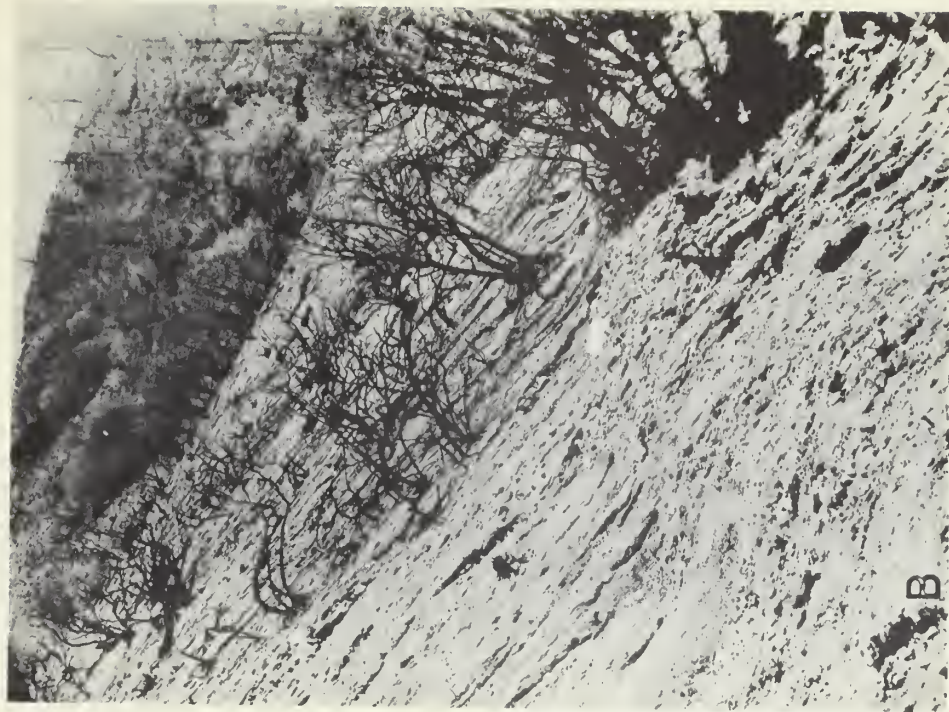
Figure 6.--Slopes above an elevation of 4,100 feet in watershed I. A: Old chaparral and bigcone spruce in 1945. B: The same slopes early in 1954 denuded by the 1953 fire and rilled by 13 inches of rain in January. Soil washing has nearly obliterated the trail.

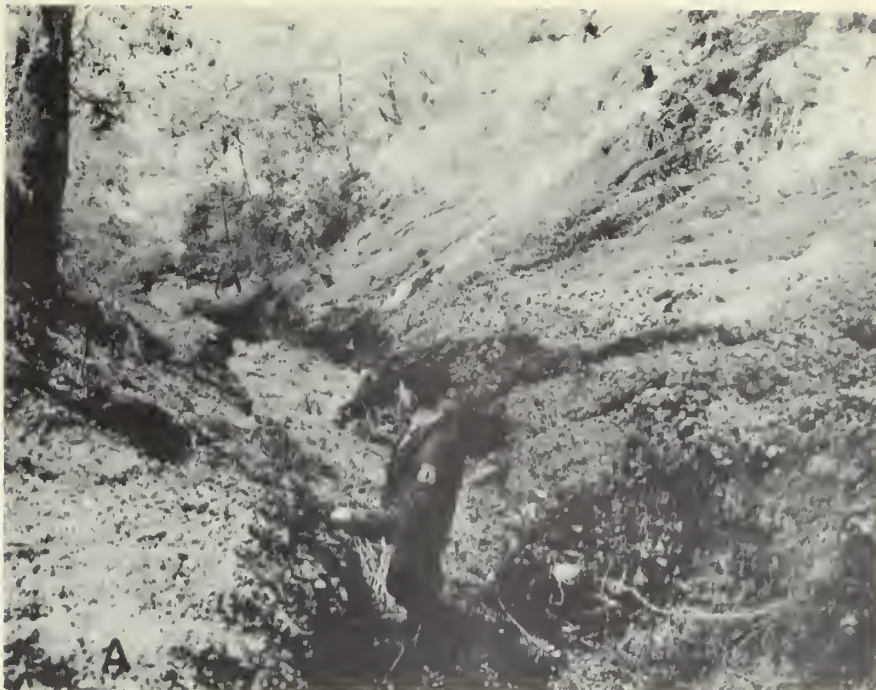
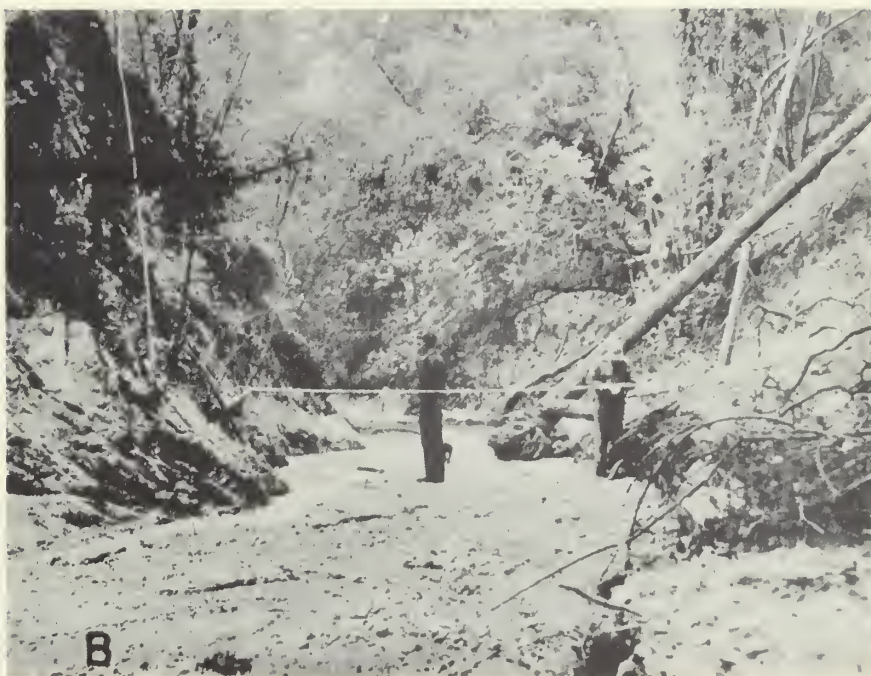
Figure 7.--Channels in watershed I after the storms of January 1954.
 A: At 4,100 feet elevation small drainages were cut to bedrock.
 B: This normally V-shaped, boulder-strewn channel below the burned area was filled 2 to 6 feet deep. The cloth strip shows the height of flood flow in one of the January storms.

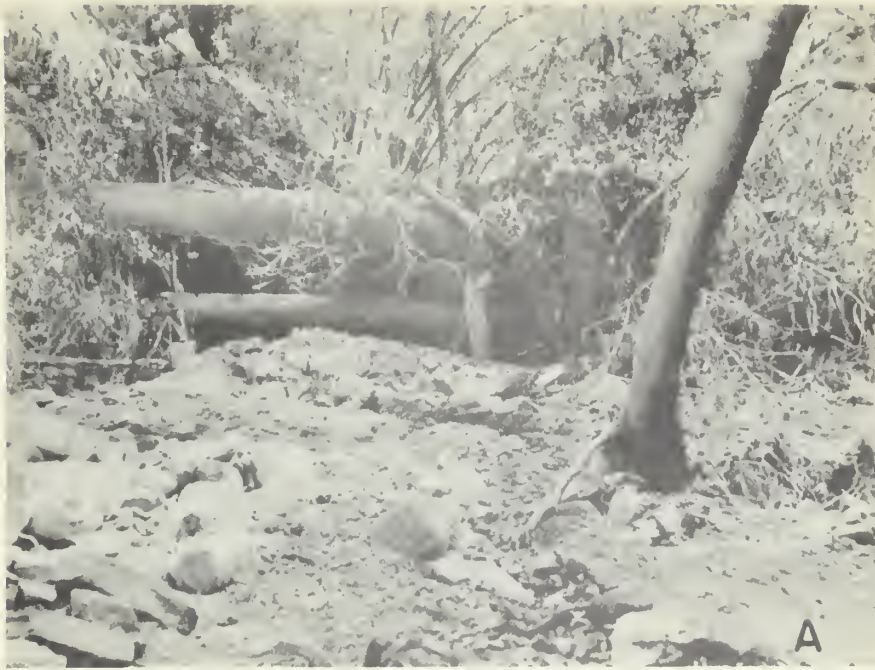
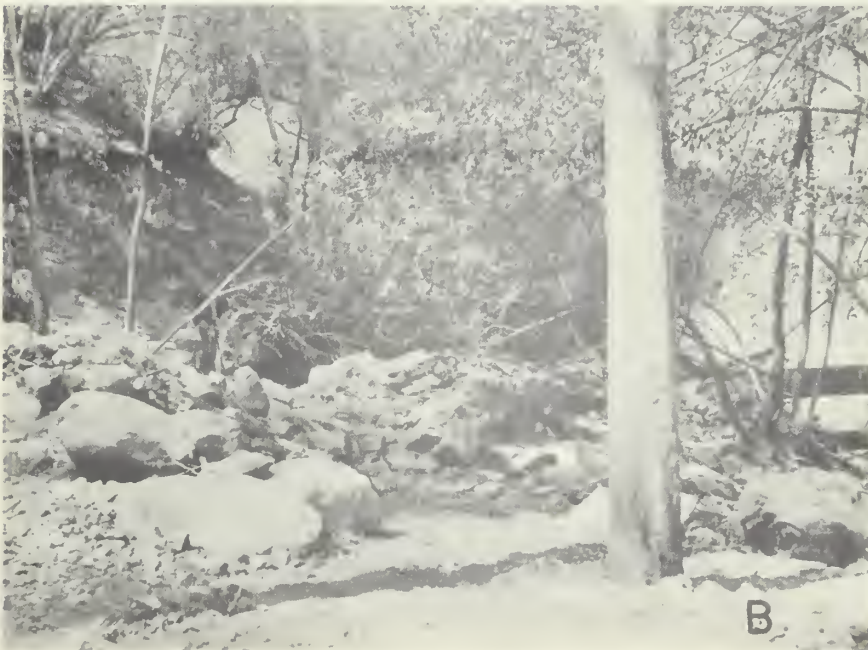
Figure 8.--The lower main channel of watershed I after the January 1954 storms. A: Looking upstream at alder logs more than 30 feet long that had washed downstream, lodged against trees, and formed a dam. B: Looking downstream at the same dam. Water had ponded against the obstruction until the debris gave way at the right.

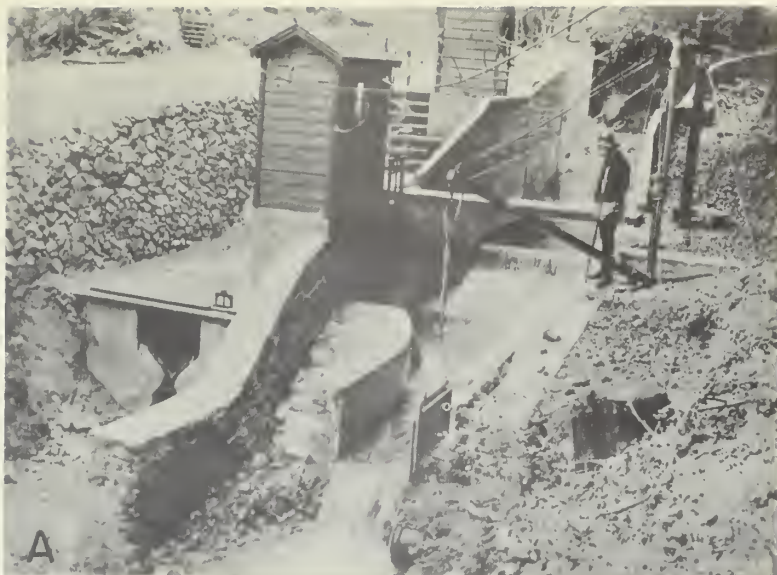
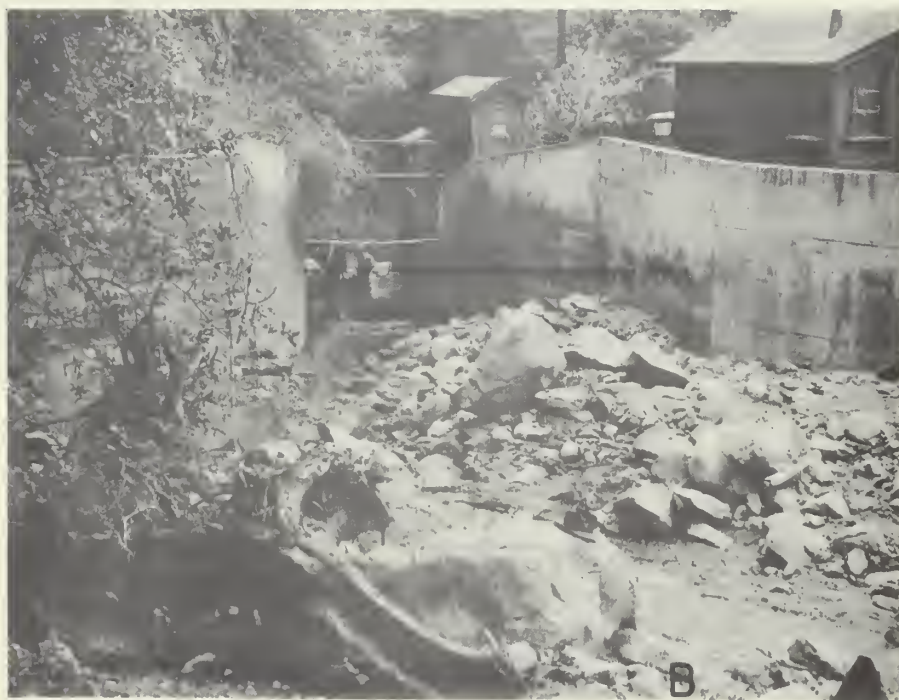
Figure 9.--The streamgaging station at the mouth of watershed I.

A: In 1941 the approach to the 10-foot flume, background, was unobstructed. During the storm of January 17-20, 1954 a boulder 4 feet in diameter was jammed into the entrance of the 3-foot flume in the foreground. B: On January 26, 1954 the upstream approach to the 10-foot flume was strewn with boulders and other debris deposited during storms of the preceding 7 days. The cloth strip shows the height of one of the flow peaks in the 10-foot flume.

"I arrived at Flume 1 (fig. 9) on January 19, 1954 at 0019. It was raining steadily, the flow was 1.8 c.f.s. in the V-notch weir and starting to get muddy (rainfall totaled 1.92 inches). I returned to Flume 6 to get Campbell, and on our way back to Flume 1 we noticed that the main San Dimas Creek was running high and muddy. Arriving at Flume 1 at 0200, we found that the 3-foot tail gate had overtopped so we changed the flow from the V-notch to the 3-foot flume immediately. The flow was 29 c.f.s. in the 3-foot flume, the first definite peak, and rain totaled 2.60 inches. By 0240 the flow increased to 43 c.f.s. bulked by mud, rocks, and debris (rainfall 2.70 inches). About this time the stillwell inlets to the 3-foot flume silted up and we started observations at the 10-foot flume. It was still raining steadily but the flow in the 10-foot flume decreased to 15 c.f.s. at 0328 (rainfall 3.09 inches). The flow then started up and by 0430 it was up to 36 c.f.s. Campbell and I were sitting in the shelter house and heard a great roar and the ground began to tremble. We ran outside and saw a great wall of water, logs, and boulders just entering the flume. In a few seconds it was past but the crest reached an average of 6.5 feet depth in the 10-foot flume (rainfall 3.66 inches). This would be a bulk flow of 1,025 c.f.s. The wave passed through the flume at 0438 and passed by the San Dimas Guard Station 1-1/2 miles downstream just 15 minutes later. By 0455 the flow had dropped to 2 feet depth (213 c.f.s.) after holding at 5 feet depth (710 c.f.s.) for about 10 minutes. This crest cleaned the channel to bed-rock except in backwaters where deposition occurred. The upper side of the flume was piled high with gravel and boulders (fig. 9B). One boulder about 4 feet in diameter lodged in the 3-foot flume. The Wolfskill Canyon road was completely washed out and the 6-inch water main was carried away where it crossed the canyon.

After the storm was over, the silt traps were cleaned out and the boulder was removed from the 3-foot flume with the aid of dynamite. This work had just been finished when the storm of January 23-25 moved in. By 3 p.m. on January 24, 1.77 inches of rain had fallen and Charles Colver was again at the streamgaging station. He says: "At about 1500 the flow was 8 c.f.s. in the 3-foot flume and very muddy. It rained steadily and at 2245, after 4.02 inches had fallen, a large crest passed through the gaging station, overtopping the 3-foot flume. Due to upstream deposits the flow in the 10-foot flume was very irregular and I had to take readings at the staff gages on both sides. This crest was about 145 c.f.s. It dropped gradually to 85 c.f.s. at 2309, to 28 c.f.s. at 2340, and 12 c.f.s. at 0033 on January 25 (total rain at this time 4.82 inches).

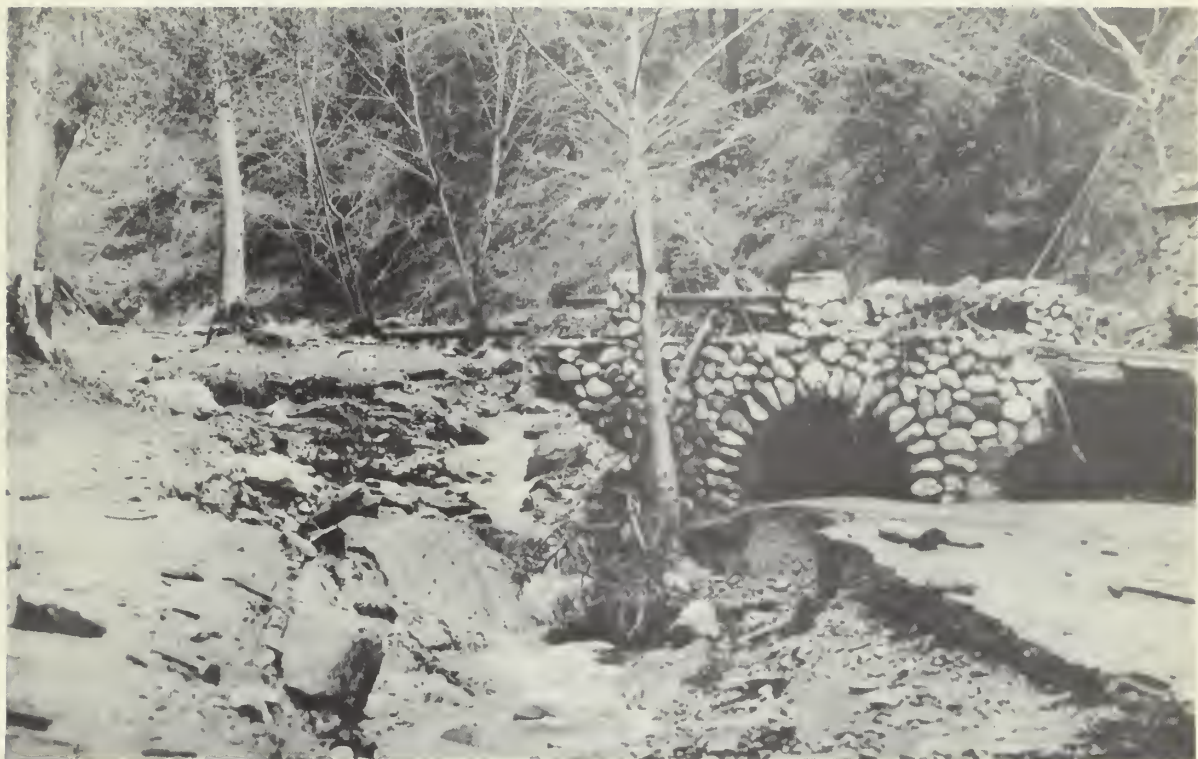
Figure 10.--Several hundred yards below the watershed I streamgaging station debris-laden flows of the January 1954 storms clogged this bridge. The diverted flows then washed out part of the bridge and cut through the road.

Erosion resulting from the fire in watershed I was not confined to the actual burned area. During the storms bank cutting and channel gouging were severe along the main stream for some 2 miles below the burned area (fig. 10). As the stream discharge dropped after the high flows, heavy deposition occurred throughout long reaches of the channel, filling some of the more gently sloping sections to the high-water mark. All the debris washed from this watershed this year, and much of the material recently deposited in its main channel, will move into the San Dimas reservoir, reducing storage capacity for water conservation and flood control.

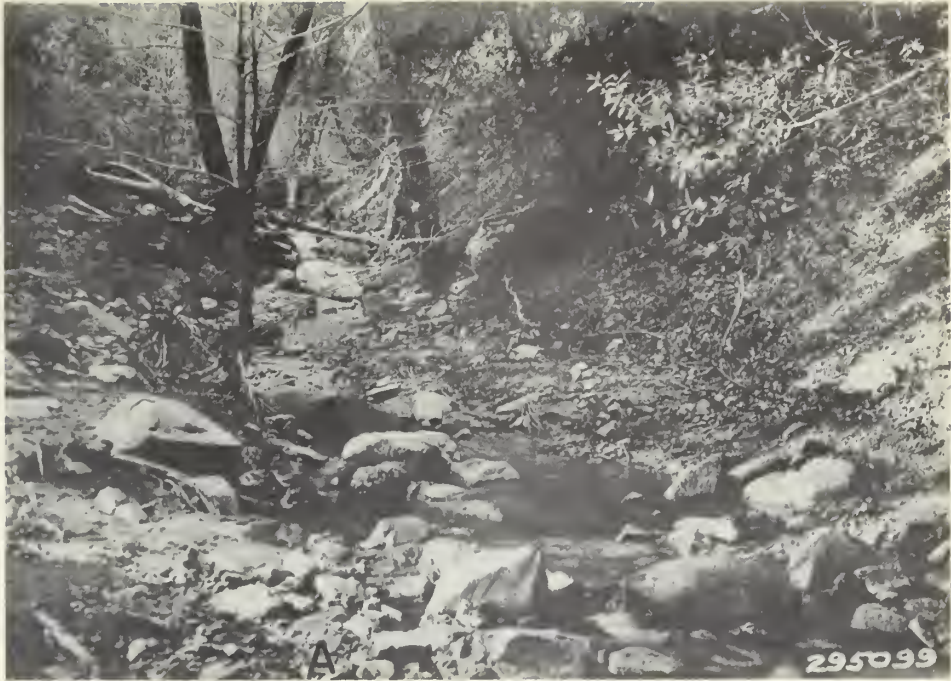
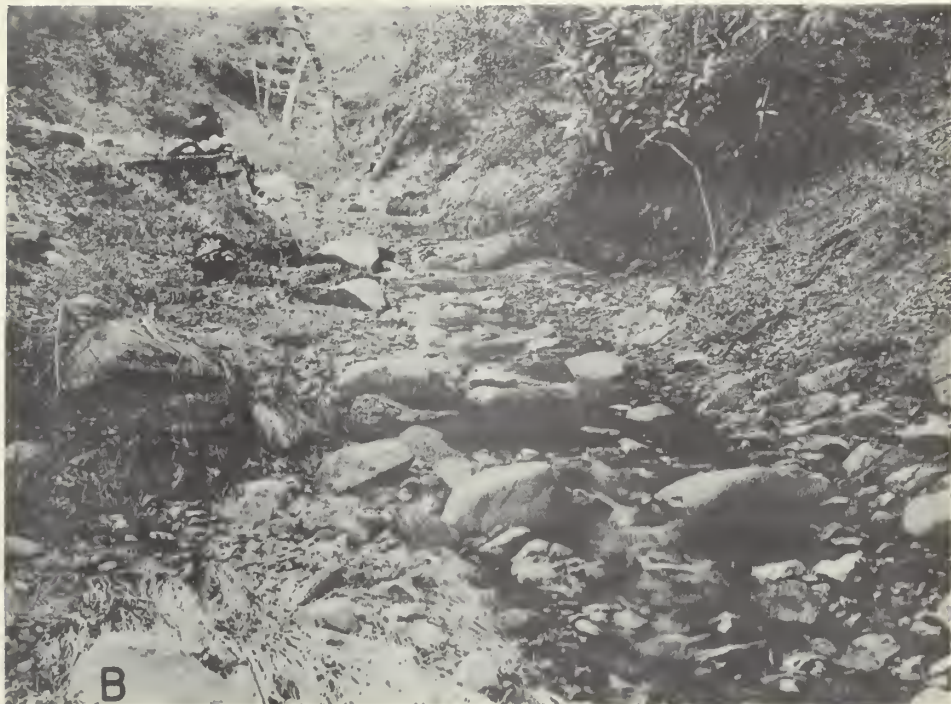
Figure 11.--The stream-bottom of watershed V, less than half a mile from the Watershed I gaging station. This watershed is almost twice the size of watershed I, and has been unburned since 1919. A: The channel in January 1934. B: The channel in March 1954, showing that little change has taken place in 20 years. Compare this with figures 7B and 9B.

The normal erosion rate for the San Dimas Canyon drainage above the San Dimas reservoir of the County Flood Control District, which includes Watershed I, has been computed from sedimentation measurements in the reservoir to be about 2,000 cubic yards per square mile per year. The erosion rate for the two storms following the fire in watershed I, then, is about 28 times the average annual rate for unburned watersheds in this area. No erosion was observed in any of the unburned watersheds of the Experimental Forest during these storms (fig. 11).

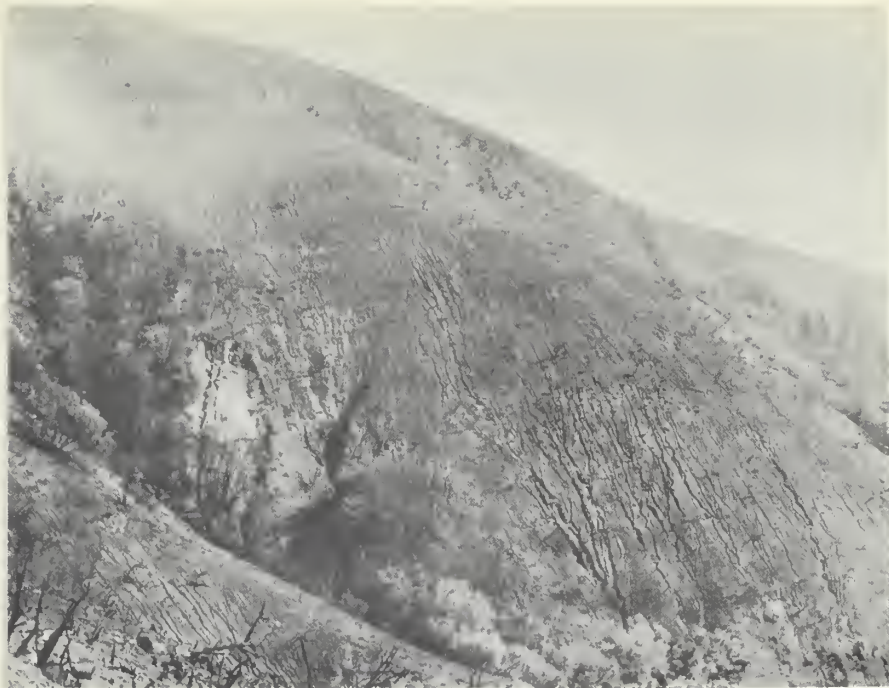
Figure 12.--The upper slopes of Palmer Canyon, just south of and outside the Experimental Forest. These slopes were burned over by the Barrett Fire break-out in December 1953, and were rilled by at least 10 inches of rain in January 1954.

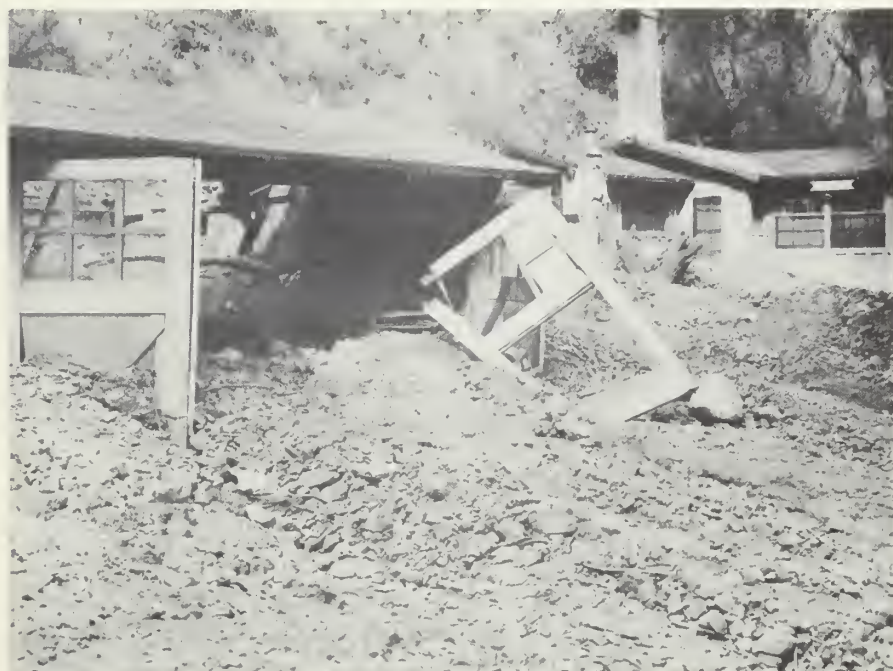
Figure 13.--The lower part of Palmer Canyon in March 1954. Mud, gravel, and rocks washed from the burned slopes and channels in January caused this damage below a tributary whose flow had previously been carried by a culvert 24 inches in diameter.

Palmer Canyon is a watershed of about 700 acres, situated just south of Wolfskill Canyon and outside the Experimental Forest. It is easily accessible from the San Gabriel and Santa Ana Valleys and, like many other shady foothill canyons, contains many cabins built for weekend retreats or yearlong occupancy. This canyon contained about 65 cabins and 20 year-round residences. The Barrett fire breakout swept over most of the headwaters of the Palmer drainage, consuming the chaparral cover down to the ground. The fire-denuded slopes were subjected to at least 10 inches of rain in the January 1954 storms. Rain ran off the bare slopes, tearing them into a network of rills and gullies (fig. 12). Flood flows concentrated in the main channels and produced debris-laden crests which surged down through the cabin-lined area, destroying the canyon road, washing away two houses, and damaging at least half of the others (figs. 13 and 15). Automobiles were washed about and some smashed into useless scrap (fig. 14). Residents had received warning and had evacuated the area. No lives were lost, but the losses in developments and property were great.

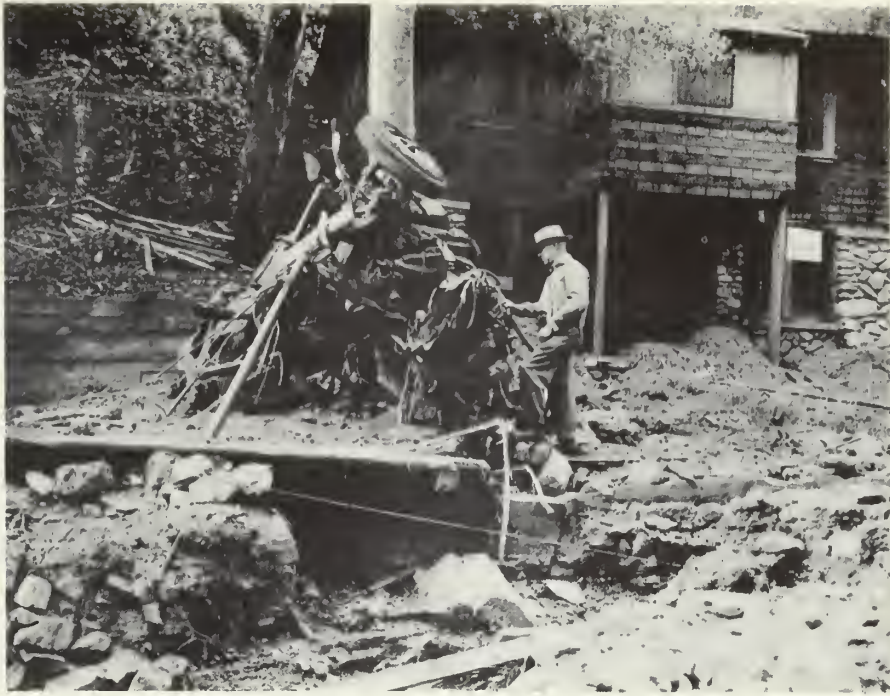
Figure 14.--Farther down in Palmer Canyon debris-laden flows sweeping through the residential section wrapped this automobile around a tree.

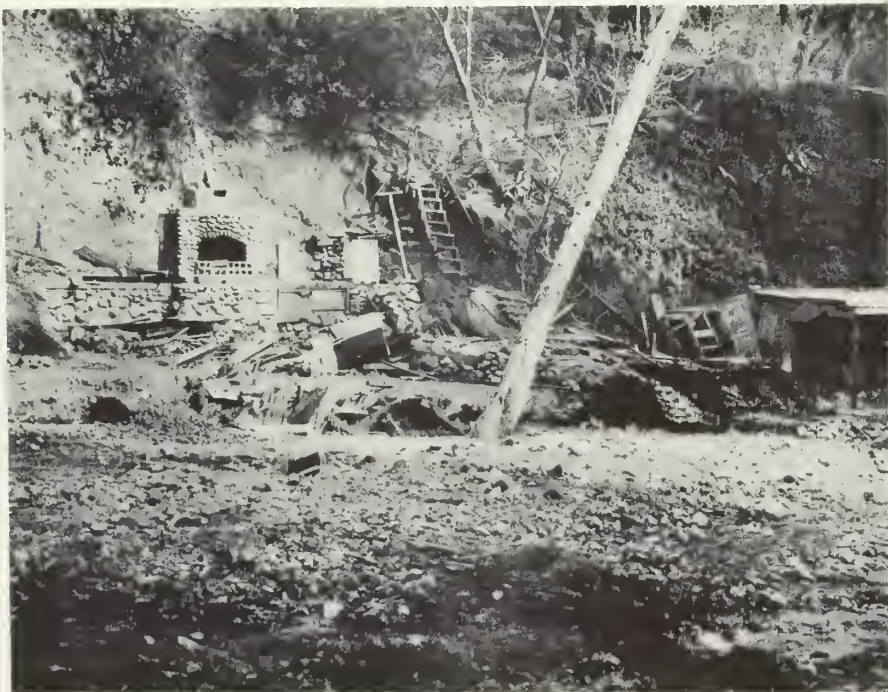
Figure 15.--Near the mouth of Palmer Canyon flood flows gained sufficient volume and speed to demolish this residence, washing away nearly everything but the living-room fireplace.
